BEAVER LAKE DAM

PHASE I INSPECTION REPORT

NATIONAL DAM INSPECTION PROGRAM

(6) National Dam Inspection Program.
Beaver Lake Dam (NDS I.D.
Number PA-354, DER I.D. Number
41-10), Beaver Lake Enterprises,
Susquehanna River Basin, Beaver
Run, Lycoming County, Pennsylvania.
Phase I Inspection Report,

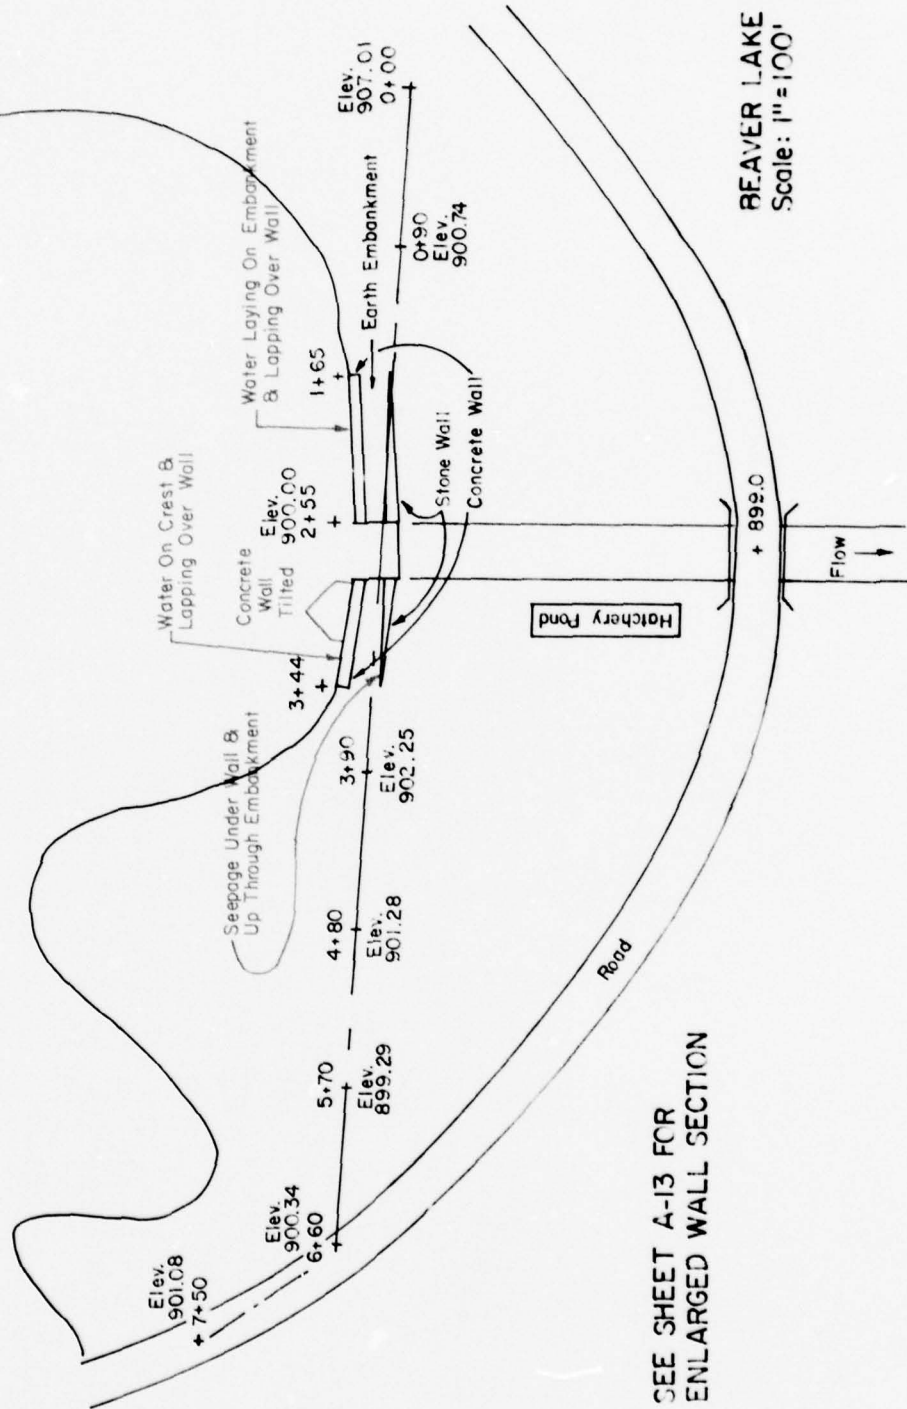
BEAVER LAKE DAM
Scale: 1"=100'

SEE SHEET A-13 FOR
ENLARGED WALL SECTION

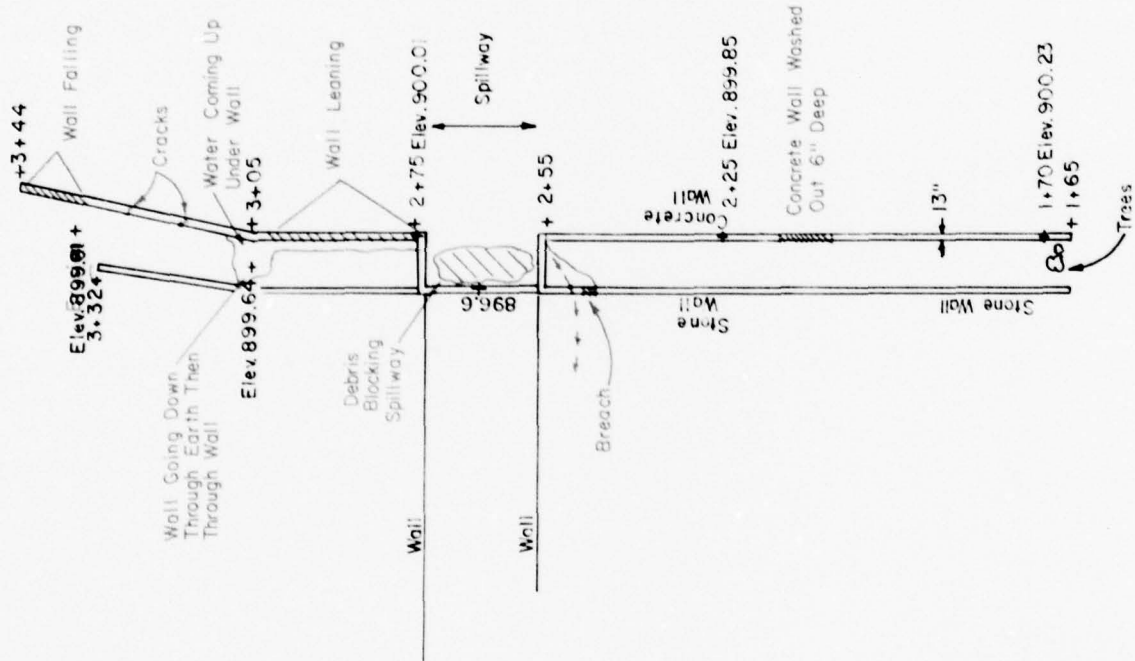
SHEET A-13
BEAVER LAKE DAM
Scale: 1" = 30'

b. Dam. The dam is in very poor condition. The concrete wall on the upstream slope is broken, cracked, deteriorated and leaning. Part of the wall to the left of the spillway has been washed out (See page A-13). To the right of the spillway most of the wall is leaning and may fail. The stone wall forming the downstream slope is in fair condition. Near the left abutment are several large trees growing on the dam. Near station 3 + 05 water is seeping through or under the concrete wall and up onto the embankment crest. The water is then flowing over the crest and down through a hole in the embankment and eventually through the stone wall. The crest varies from elevation 899.8 to 900.2. Water level at the time of inspection was at elevation 899.7. Wave action was carrying water over the crest. In addition, a breach in the spillway left wall was carrying more water over the embankment to the left of the spillway than through the spillway.

4. The concrete wall should be repaired and stabilized.
5. The left spillway wall should be repaired.
6. All holes and erosion of the embankment should be repaired.
7. The trees on the embankment should be selectively removed under the direction of an engineer knowledgeable in dam design.
8. A warning system should be instituted to warn downstream residents or large spillway discharges or failure of the dam.
9. Institute a formal safety inspection program to be conducted at regular intervals.
10. A method to drain the reservoir should be developed.
